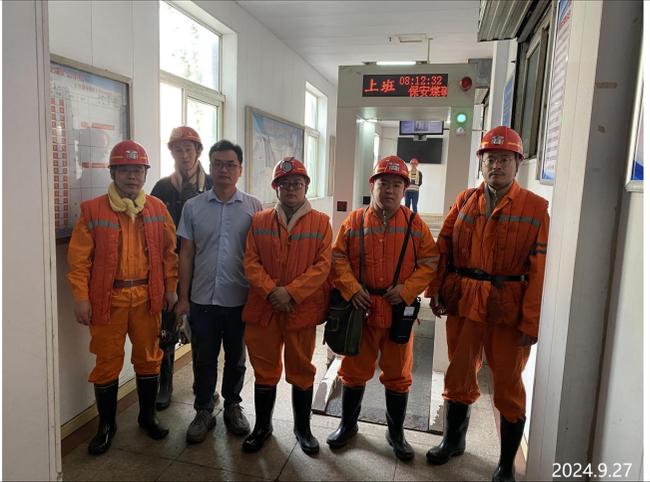
序号	报告编号	发布日期	结论	影像资料
42	GX-B1345/21-9-24002	2024.12.23	<p>1、矿井需要风量：3385m³/min； 布置2个采煤工作面、4个掘进工作面； 2、矿井总进风量：3580m³/min； 3、矿井总回风量：3663m³/min； 4、矿井等积孔：1.84m²； 5、矿井有效风量率：89.8%； 6、矿井外部漏风率：2.6%。 查通风机报告性能曲线：东台通风机风压1550Pa（负压1635Pa），风量63.20m³/s（3792m³/min），轴功率158.5kW；西台通风机风压1555Pa（负压1635Pa），风量63.00m³/s（3780m³/min），轴功率157.5kW。 核定矿井通风能力：45.0万吨/年。 核定采掘工作面个数：2个采煤工作面，4个掘进工作面。</p>

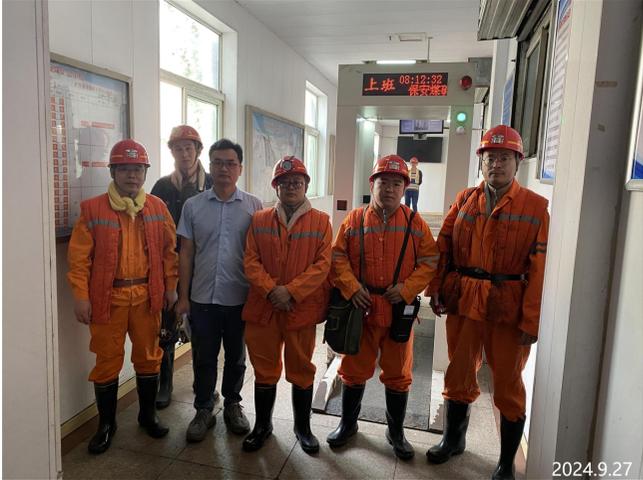
55	GX-B1342/21-9-24004	2024.12.30	<ol style="list-style-type: none"> 1. 矿井总进风量： 3580.6m³/min; 2. 矿井总回风量： 3663.2m³/min; 3. 全系统计算阻力值： 1606.1Pa; 4. 全系统测定阻力值： 1634.3Pa; 5. 矿井等积孔1.84m²。

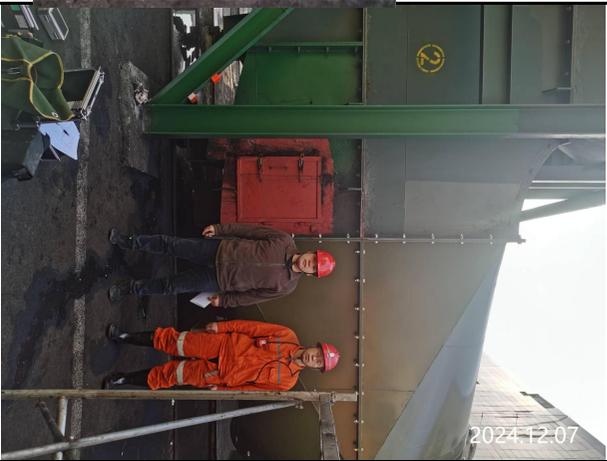
70	GX-B1340/23-9-24068	2024.12.30	2#在用主要通风机系统合格。

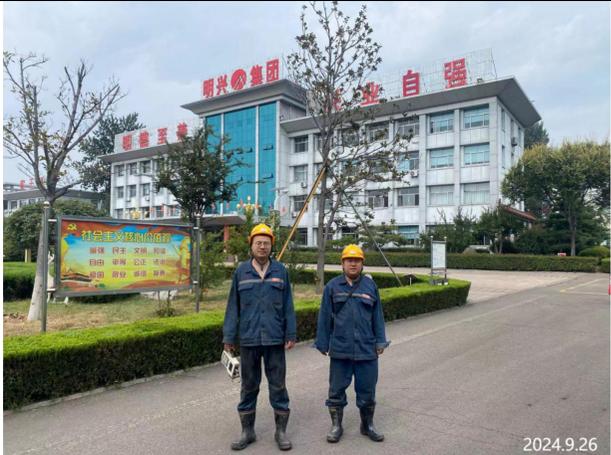
99	GX-B1345/21-9-24003	2024.12.31	<p>1、矿井需要风量：4353m³/min； 布置2个采煤工作面、1个备用工作面、5个掘进工作面； 2、矿井总进风量：4763m³/min； 3、矿井总回风量：4869m³/min； 4、矿井等积孔：2.20m²； 5、矿井有效风量率：88.1%； 6、矿井外部漏风率：2.9%。 查通风机报告性能曲线：1#通风机风压1875Pa（负压2040Pa）时，风量84.30m³/s（5058m³/min）；2#通风机风压1870Pa（负压2040Pa）时，风量85.60m³/s（5136m³/min）。 核定矿井通风能力：69.2万吨/年。 核定采掘工作面个数：2个采煤工作面、1个备用工作面、5个掘进工作面。</p>
